Intel[®] Mobile Pentium[®] II Processor Specification Update

Release Date: April 2000

Order Number: 243887-020

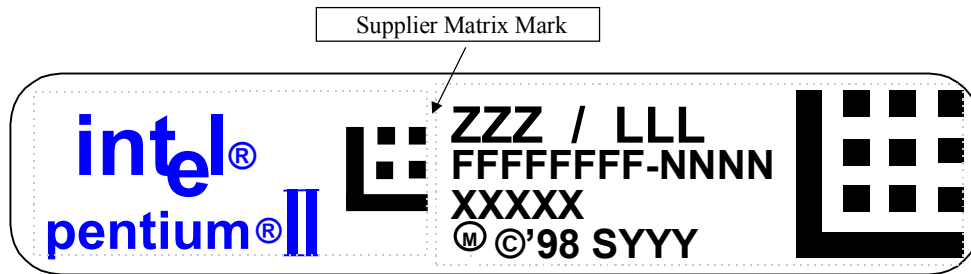
Old Mobile Pentium® II Processor in Mini-Cartridge Package Label with Supplier Matrix Mark

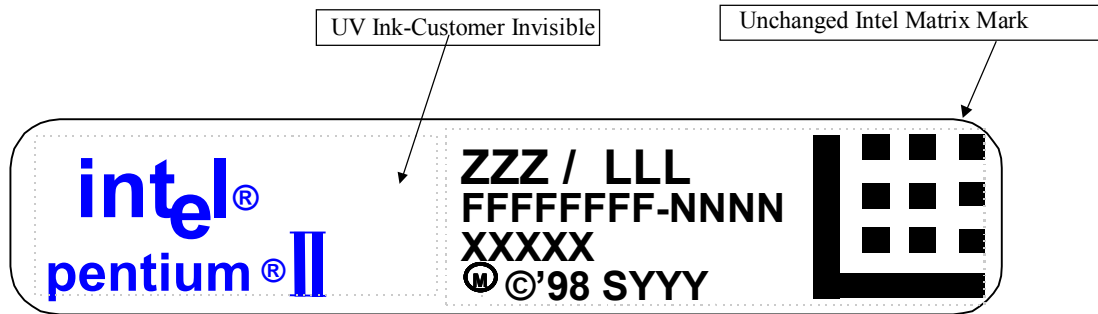
New Mobile Pentium® II Processor in Mini-Cartridge Package Label with Supplier Matrix Mark Removed

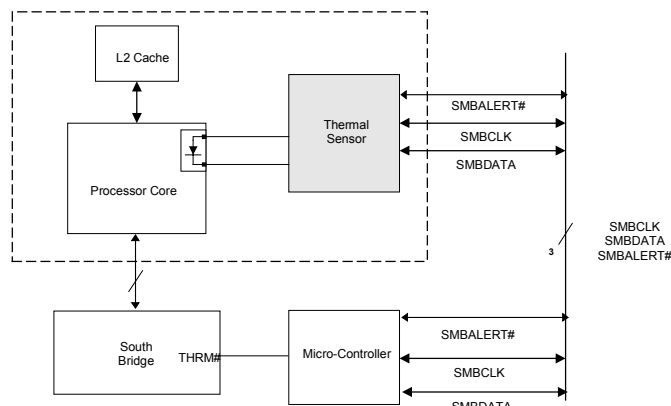
Figure 1. An Example of Microcontroller Driven Thermal Management

B30. Thermal Sensor May Assert SMBALERT# Incorrectly

Problem: The Mobile Pentium II processor and the Pentium II Processor Mobile Module have a thermal sensor that monitors the processor core's temperature. Please note that desktop systems could have a similar thermal device. The thermal sensor asserts SMBALERT# if the processor temperature exceeds the temperature limits set in the Alarm Threshold Registers (T_{HIGH} , T_{LOW}). It also sets the corresponding Status Register bits to identify the cause of the interrupt. Figure 1 gives one example of the how the SMBALERT# signal could be used in a system.

Under the conditions described below, the thermal sensor incorrectly generates the SMBALERT# interrupt. All of the following conditions must be met to trigger a false interrupt:

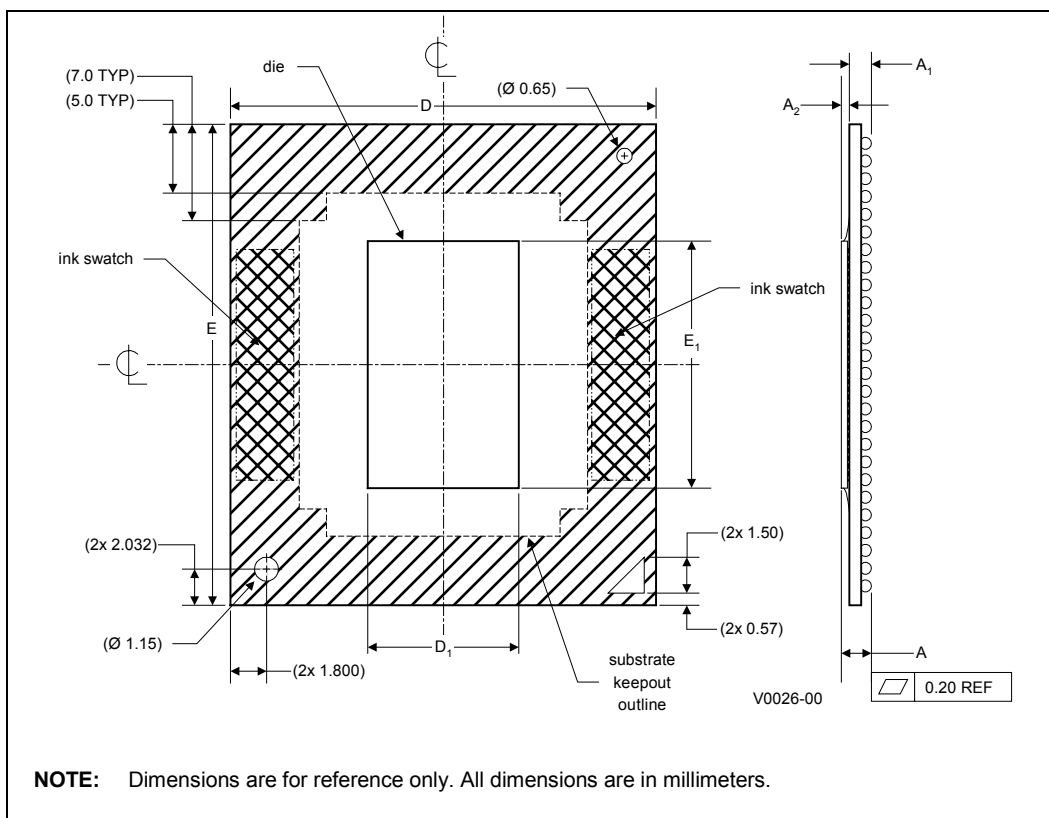
Figure 5.3. Surface-Mount BGA1 Package—Top and Side View

The following table and figures show the updated mechanical specifications for the BGA1 package, listed as Table 5.2, Figure 5.3 and Figure 5.4, respectively, in the *Mobile Pentium® II Processor in BGA Package at 366 MHz, 333 MHz, 300PE MHz, and 266PE MHz* datasheet.

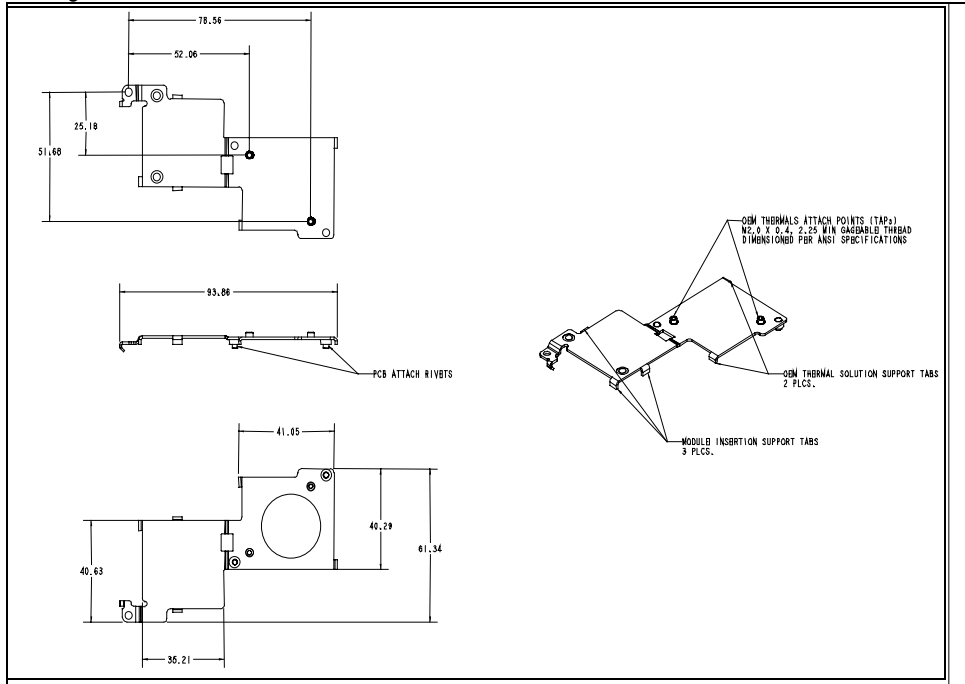
Figure 1. TAP Gageable Thread Clarification

OEM Thermal Attach Points (TAPs) M2.0 x 0.4, 2.25 min gageable thread dimensioned per ANSI specification.

See Figure 1 below for more information.
